Case Report

Rehabilitation of badly broken-down maxillary anterior with custom cast post and core

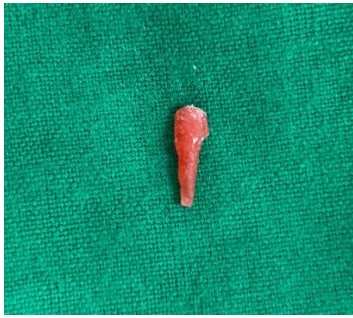
An indirect technique was then used to create the metal post. A separating medium was applied to the root canal walls, and a Pinjet (Angelus, Brazil) was used to record an impression of the post using pattern resin (GC America, Pattern Resin) (**Figure 4**, **Figure 5**, **Figure 6**).

Figure 5: Recorded pattern of the post space

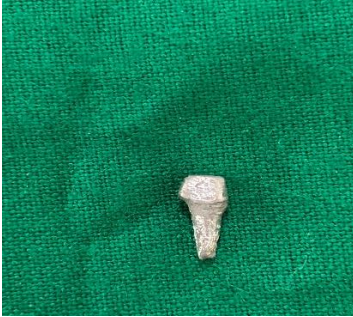
Figure 6: Fabricated cast post and core

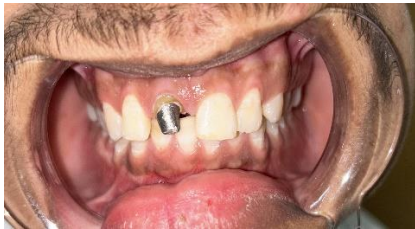
Luting glass ionomer cement was used to cement the metal post (**Figure 7**, **Figure 8**). An intraoral scan was sent to the lab after proper shade selection for the fabrication of the porcelain-fused metal crown (**Figure 9**). Cementation of the porcelain-fused metal crown was done using glass ionomer cement (**Figure 10**).

Figure 7: Luting of cast post & core

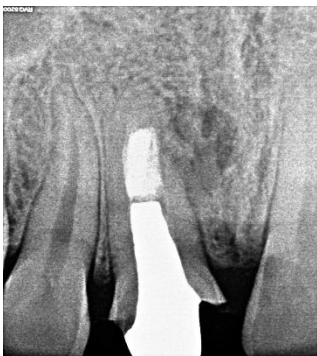
Figure 8: Radiograph after Luting

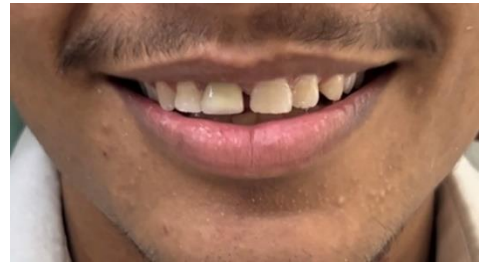
Figure 10: Final prosthesis in the patient's mouth

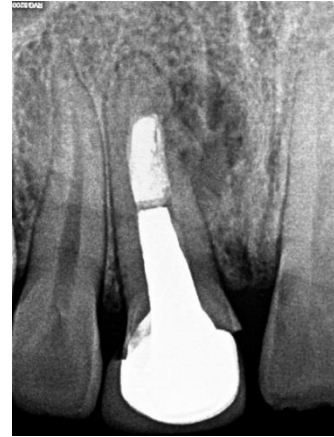
Figure 11: 6 Months follow up

The outcome of the current case was extremely satisfying in terms of restoring a severely damaged tooth, which was brought back into function utilizing a custom-made cast, a ferrule, and a core over it to support and strengthen the final prosthesis. Follow-up assessments at 6 months (**Figure 11**) of the present case, with a stable post and core and crown, along with healthy gingival margins, have confirmed that the restoration remains stable, functional, and aesthetically pleasing—highlighting the ongoing relevance of this treatment approach in modern dental practice.
