Biodentine as material of choice for furcal perforation repair – A case report

Case Report

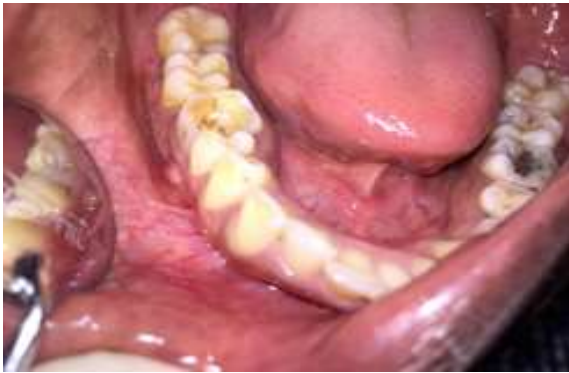
A 28 year old male patient came to the Department of Conservative Dentistry and Endodontics with a chief complaint of continuous dull pain since 6 months, a boil on his gums and dislodgement of a restoration in the lower right posterior region 1 day ago. The tooth was slightly tender on percussion and showed no mobility. The patient gave a history of root canal treatment 6 months prior which he had discontinued halfway. Intraoral examination (Fig. 1) Clinical examination

Fig. 1: Pre-operative clinical view showing the dentoalveolar abscess

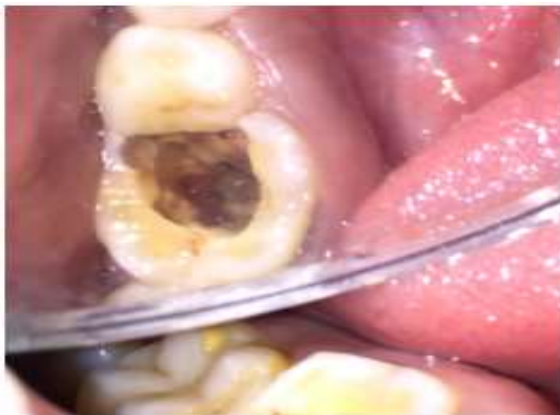
revealed a large access cavity and a perforation of 1.5 x 2 mm on the floor of the chamber (Fig. 2). Radiographic examination revealed a radiolucency in the floor of the chamber along with periapical radiolucencies in all three roots (Fig. 3). Patient was informed about the situation and it was decided to attempt repair of the perforation followed by root canal treatment. A signed consent was obtained from the patient and the treatment was initiated. The access cavity was refined and working lengths were determined using a no.10 and 15 files (Fig. 4). The canals were cleaned and shaped upto F2 with copious saline irrigation. Once cleaning and shaping was completed, the canals were then blocked with files to prevent the entry of the reparative material (Fig. 5). Biodentine™ was manipulated by mixing five drops of the liquid provided by the manufacturer into the capsule. The capsule was then placed on a mixing device, Technomix, at a speed of 4000–4200 rotations/minute for 30 seconds. The mix was carried to the site of perforation. A plugger was used to condense the mix at the site (Fig. 6). After the Biodentine™ had set, the files were removed from the canals and calcium hydroxide was placed in the canals. A cotton pellet was placed in the chamber and the access was temporized with zinc oxide eugenol. The patient was recalled after a week. The dentoalveolar abscess had reduced in size and no discharge was seen from the canals. The canals were irrigated with saline and a second calcium hydroxide dressing was given for another week. At the third appointment, the dentoalveolar abscess had resolved and the patient was asymptomatic (Fig. 7). The canals were irrigated and obturated by lateral condensation on a four month follow up, a radiograph was taken which showed that the periapical radiolucencies had reduced considerably along with absence of radiolucency in the furcal area (Fig. 9). The

Fig. 2: Pre-operative clinical view showing the furcation perforation

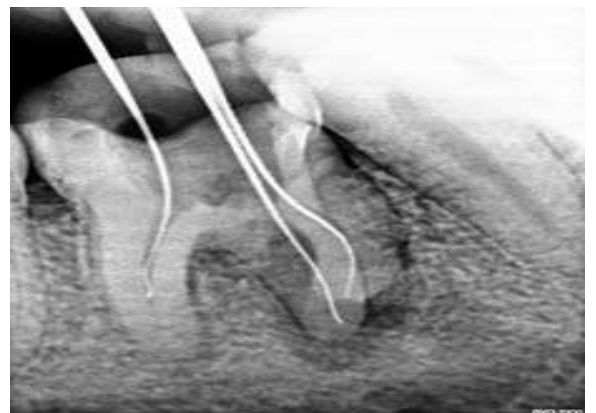
Fig. 6: Blocking of canals with files and repair with biodentine

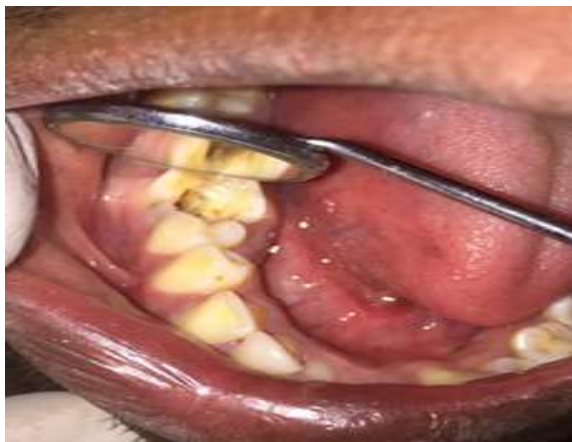
Fig. 7: Resolution of dento alveolar abscess

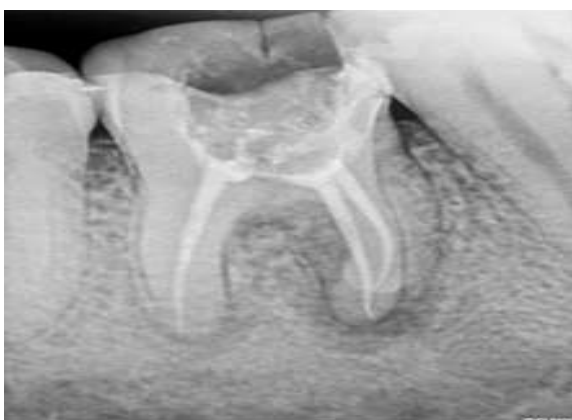
Fig. 8: Obturation of the canals

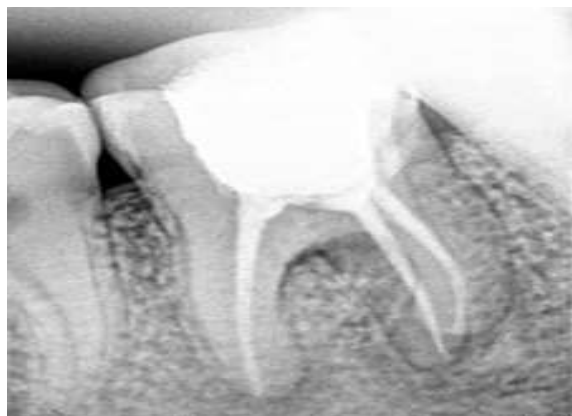
tenderness on percussion had subsided and there was no recurrence of the dentoalveolar abscess.

Fig. 9: 4 month follow up
