IP Annals of Prosthodontics and Restorative Dentistry

Case Report

Endodontic management of a mandibular molar with self implanted foreign bodies and repair of furcral perforation using biodentin – A case report

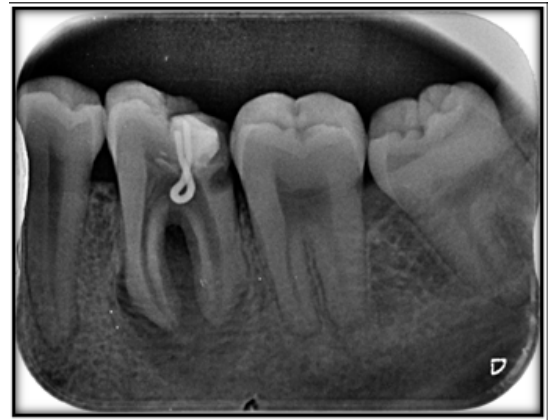
Fig. 1: Pre-operative radiograph showing the presence of foreign body in the pulp chamber of tooth # 46.

A 22-year-old male patient reported to the Department of Conservative Dentistry & Endodontics, ESIC Dental College & Hospital, New Delhi with the complain of mild pain in lower right back teeth region for 2 weeks especially after having food. The pain used to radiate to the ear and temporal region and was relieved either by taking analgesics and/or removing food that was lodged within the tooth. Clinical examination revealed an access cavity prepared in tooth # 46 with loss of temporary restoration and subsequent food lodgement. Radiographic examination revealed the presence of a radio-opaque object in the pulp chamber of tooth # 46 along with radiolucency involving the furcral region. (Figure 1) After careful assessment of the clinical and radiographic findings, retrieval of the foreign object and subsequent completion of endodontic therapy was planned.

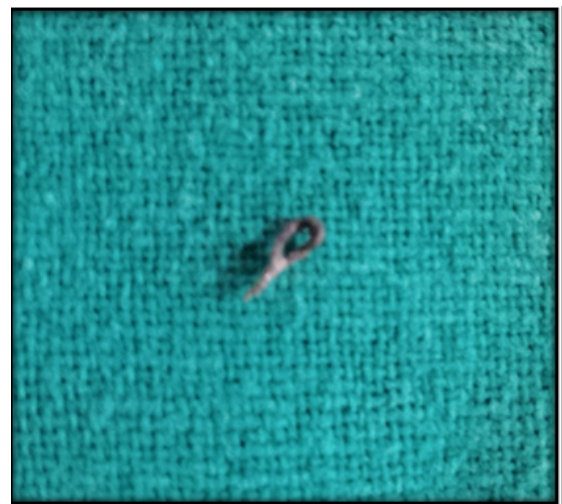
Fig. 2: Metal wire (Foreign Object) retrieved from the pulp chamber.

Conventional access cavity preparation was prepared under rubber dam isolation. Irrigation was done using 5.25% sodium Hypochlorite (Parcan, Septodont) and normal saline solutions. After a series of attempts the foreign object was removed from the chamber using a Stieglitz forceps. Successful retrieval of the foreign object from the pulp chamber was confirmed by taking a radiograph. The object was a loop of a metal wire with sharp ends and measured approximately 11 mm in length. (Figure 2) Pulp was extirpated and at this point a perforation defect was noted in the furcral region.

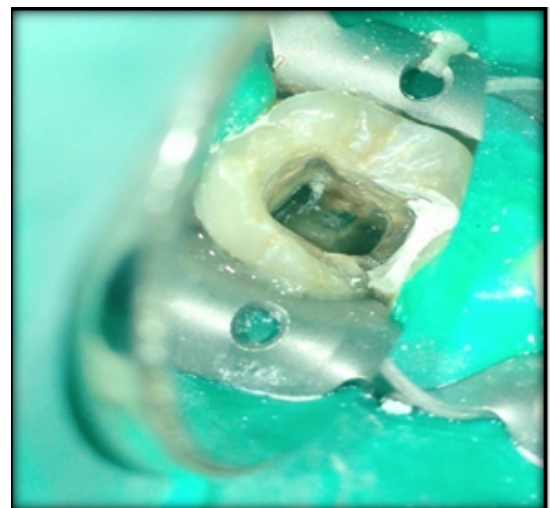
Fig. 3: Intra oral view of the chamber showing the presence of furcation defect at the floor of the pulp chamber of tooth # 46.

(Figure 3) The patient was informed about the guarded prognosis and the perforation defect was repaired and sealed with Biodentine under magnification from dental loupes at 3.5X magnification (Heine Dental Loupes, Heine Optotechnik, Germany) as per manufacturer's instructions (Septodont India Pvt. Ltd.) (Figure 4) The tooth was temporized and the patient recalled after one week.

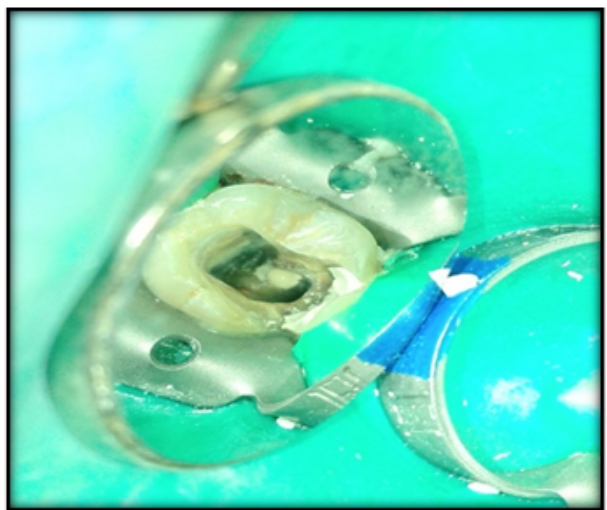
Fig. 4: Perforation repaired using Biodentine.

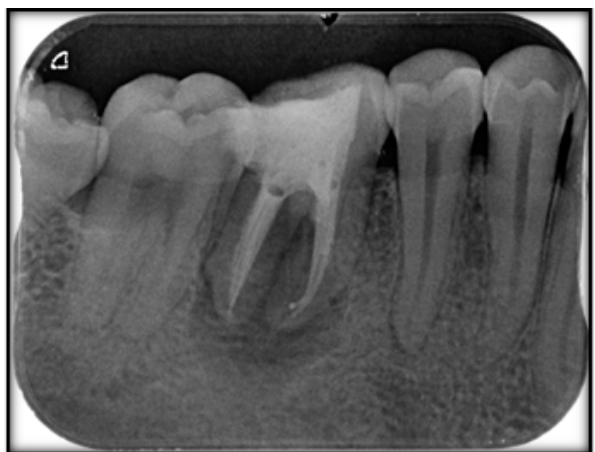
Fig. 5: Post-operative radiograph.

In the subsequent visits, working length was determined using apex locator and biomechanical preparation was completed with NiTi hand files (Mani Inc. Japan). Finally, the root canal was irrigated with normal saline and 2 % chlorhexidine (Amdent) was used as a final rinse. An intracanal medicament containing calcium hydroxide (Metapex) was administered for two weeks. After this two-week interval, the tooth remained asymptomatic and obturation was done with gutta-percha using lateral condensation technique. (Figure 5)
